**Spektrum DX6i Stick Pot Service Bulletin**

**X9303 2.4GHz Gimbal Wire Service Bulletin**

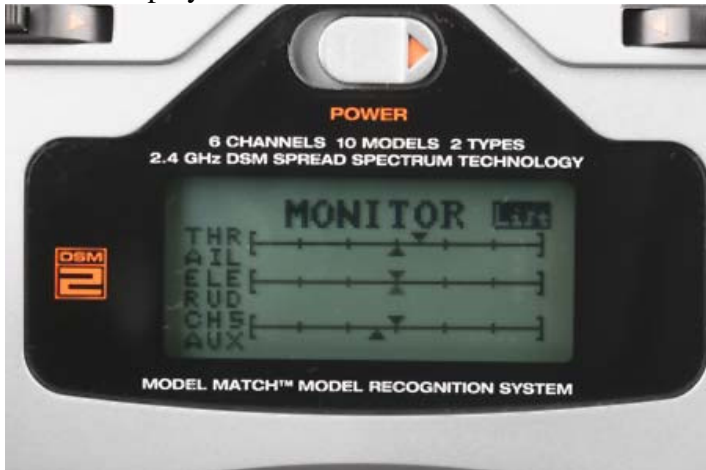
1) Turn on your transmitter and select the servo monitor display

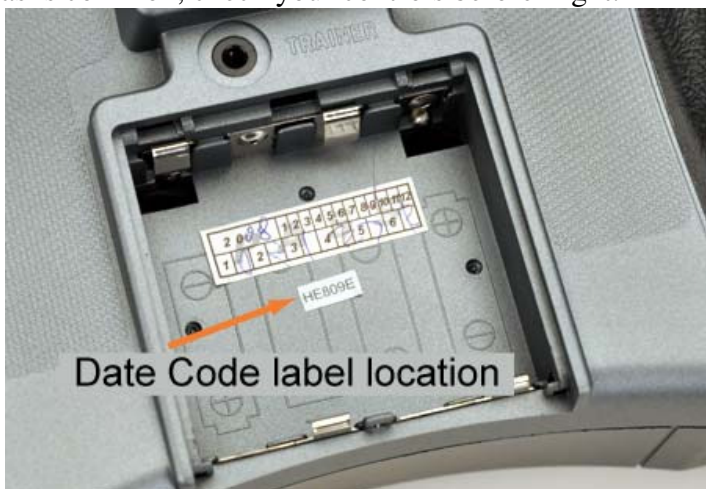
3) The monitor should show smooth movement tracking with the input. If the monitor “jumps” or hesitates, please send your system in for service using one of the links below.

Radios with a date codes of 809E, 810E, 811E, 812E should be carefully checked. If your radio does not have a date code, the test is still advisable. And please, as is common, check your controls before flight.

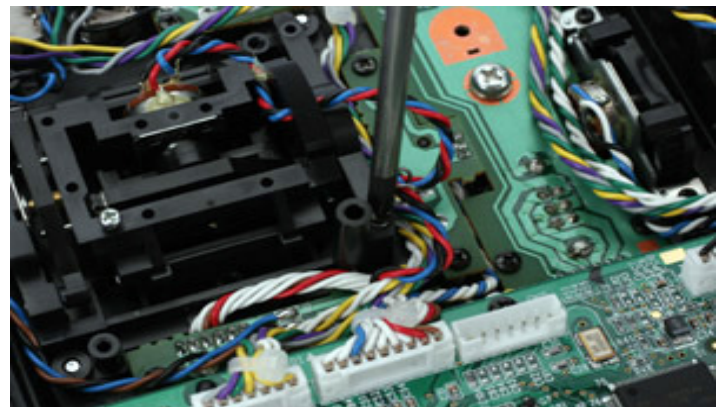
The JR Service Center has discovered that many of the X9303 2.4 transmitters have an issue in that the wires attached to the aileron potentiometer can come into contact with the voltage regulator that is mounted in the back of the transmitter. With repeated use it is possible that the insulation can wear through exposing the wire at the point that it contacts the regulator. It is recommended that the aileron potentiometer wires be rerouted per the following instructions and photographs. This notice does not affect XP9303 72 MHz transmitters.

**Step 2.** Inspect the aileron potentiometer wires for any damage. If the insulation is worn and strands are broken or damaged return your system for service to the Horizon Service Center.
